# Full View

18th February 2022

RE: Report of the Roof Coverings at [REDACTED] via drone.

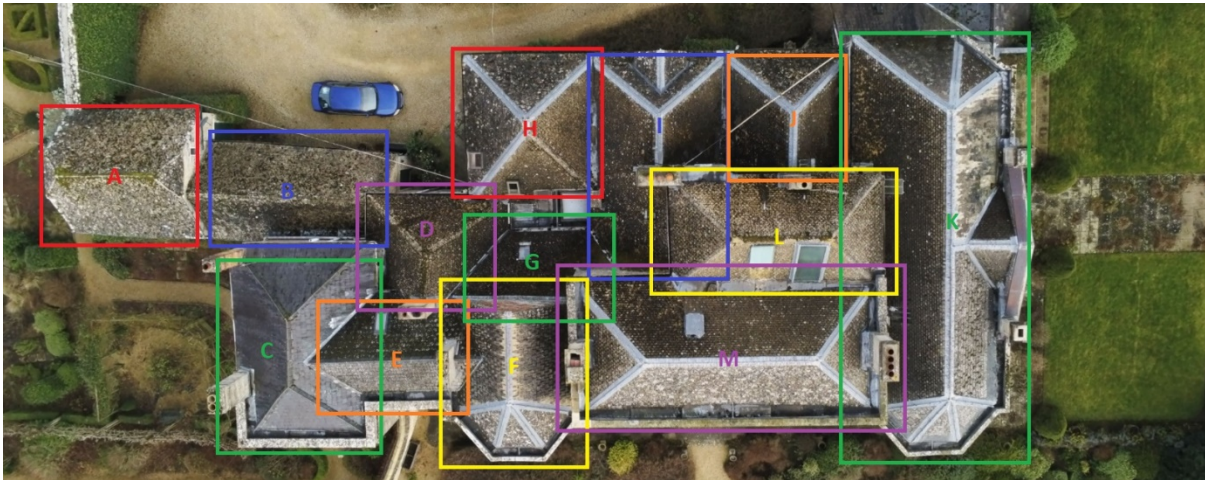
This survey is a survey of the roof elevations of [REDACTED] via Drone. The roof elevations are split up into 13 sections (A-M) as shown in the below marked up picture. There have been a multitude of roof coverings and details used over the roof as a whole. A summary of each section is to be provided and repairs required are to be highlighted in the inspection report towards the back of this survey.

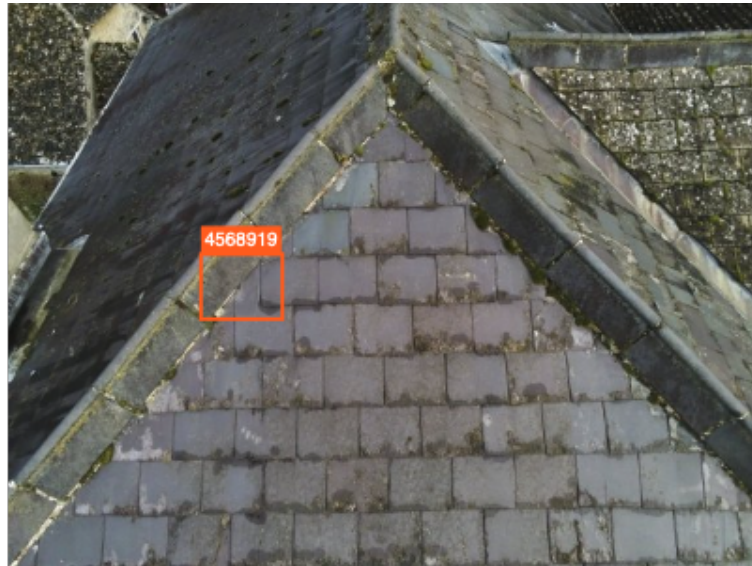
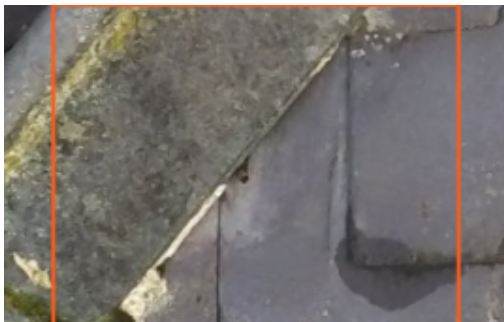
4568919 Severity: 3 Missing tile

Missing slate next to hip detail

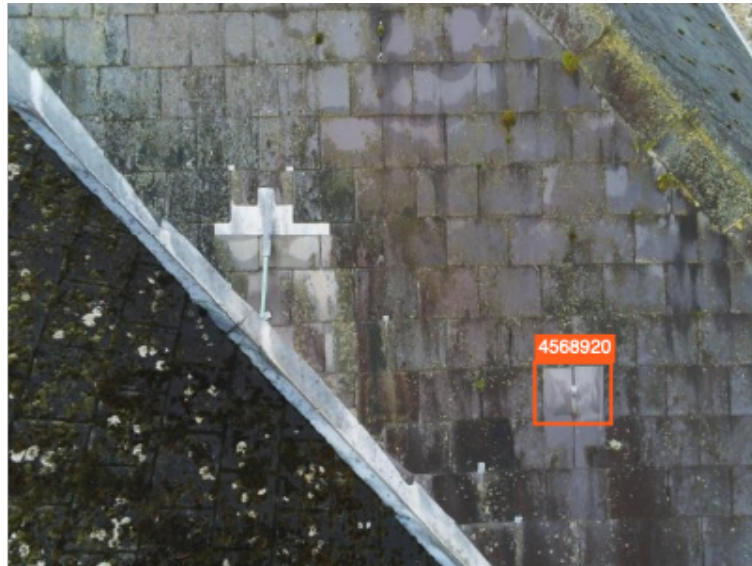
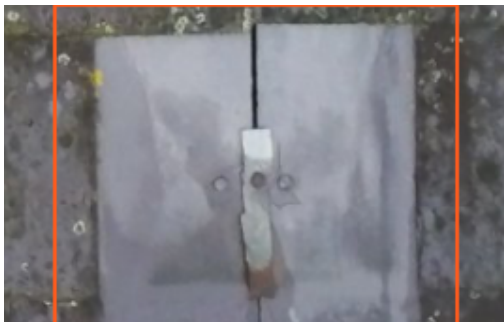
4568920 Severity: 3 Missing tile

Missing slate

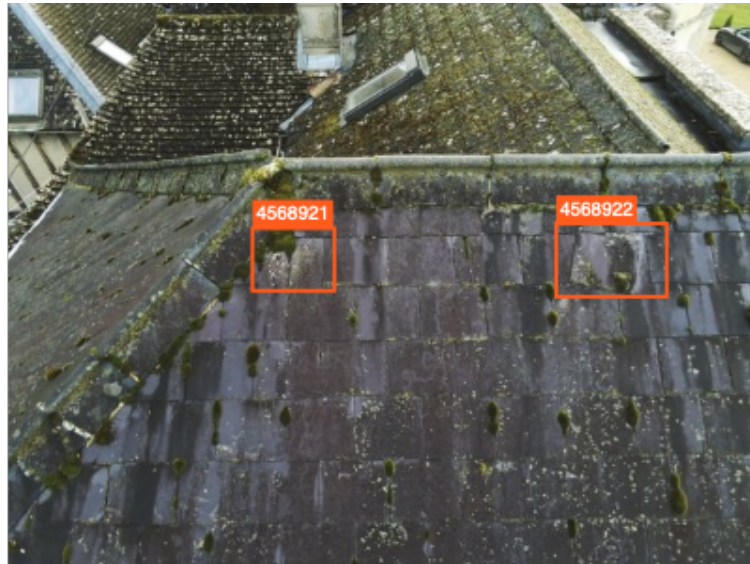
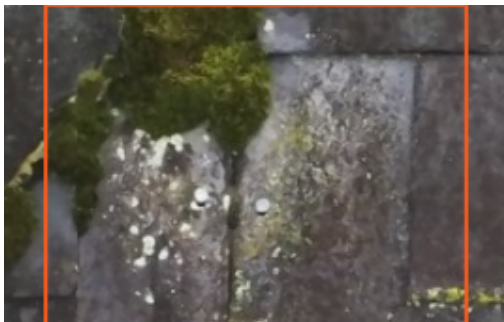
4568921 Severity: 3 Missing tile

Missing slate close to hip

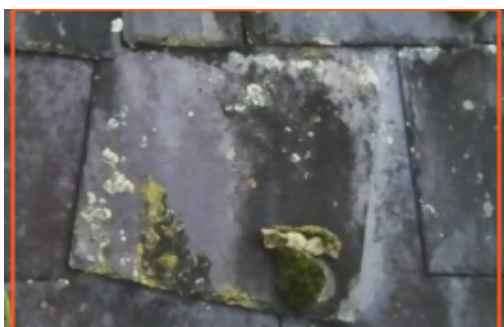
4568922 Severity: 3 Missing tile

Slipped slate to top course

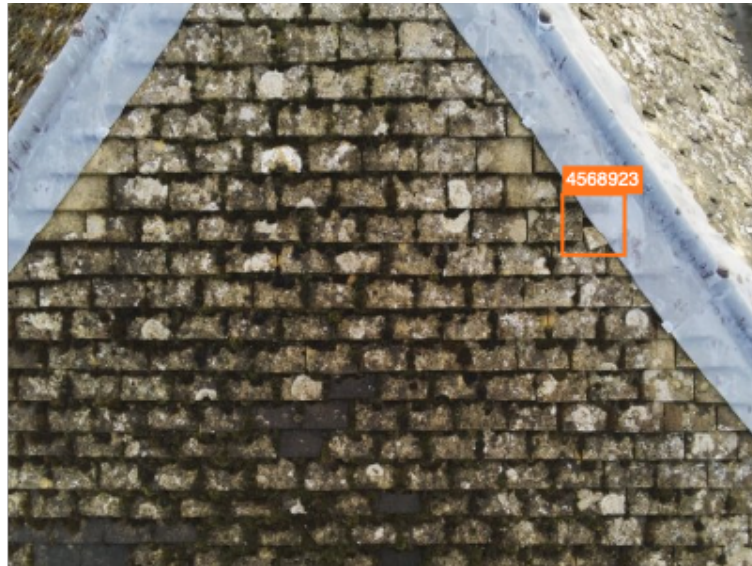
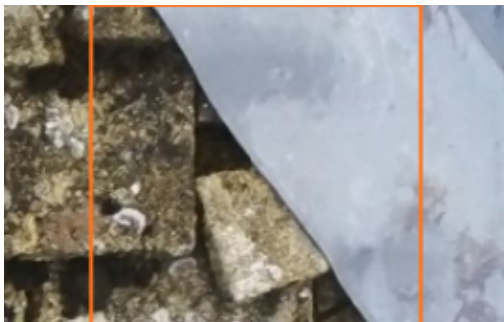
4568923 Severity: 2 Broken tile

Broken tile to hip detail

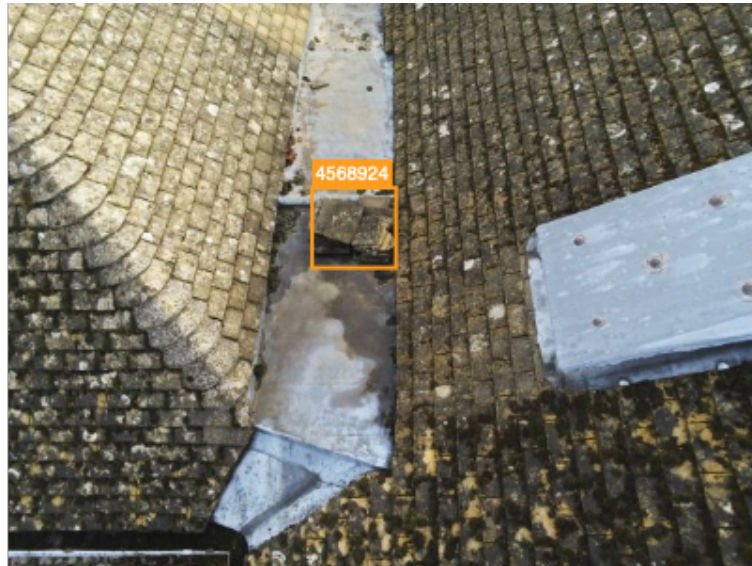
4568924 Severity: 1 Debris

Tiles to be removed from box gutter

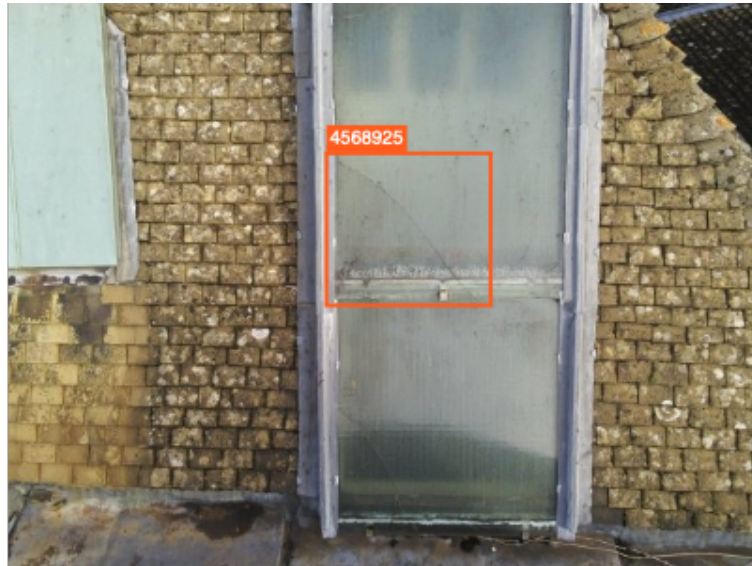
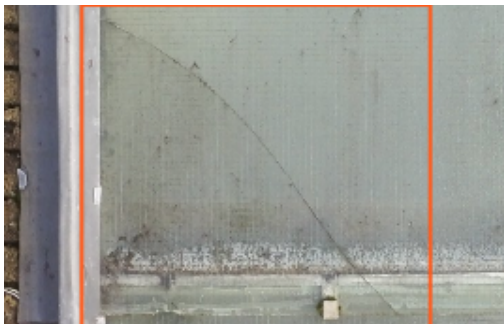
4568925 Severity: 3 Worn section

Splits in glass panes of sky light

Broken glass panes to roof lights should be remedied as soon as possible to prevent water ingress. It could be worthwhile upgrading these to conservation roof lights should planning allow it.

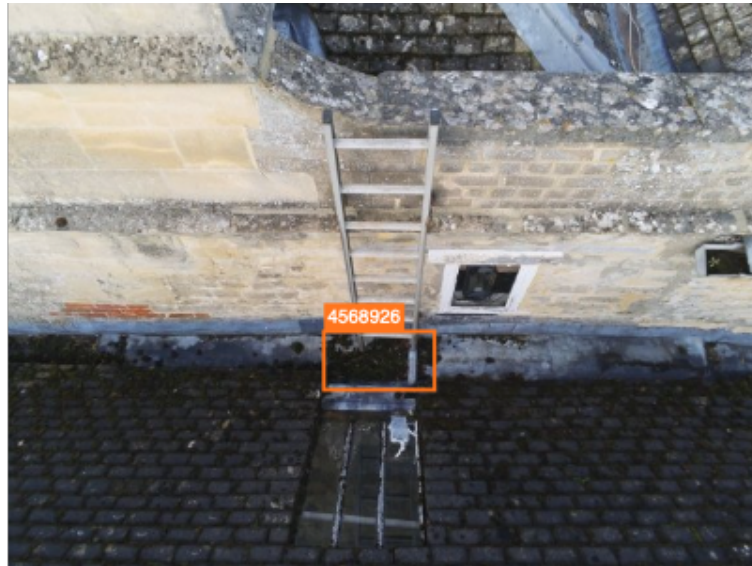
4568926 Severity: 2 Debris

Small amount of debris build up in box gutter

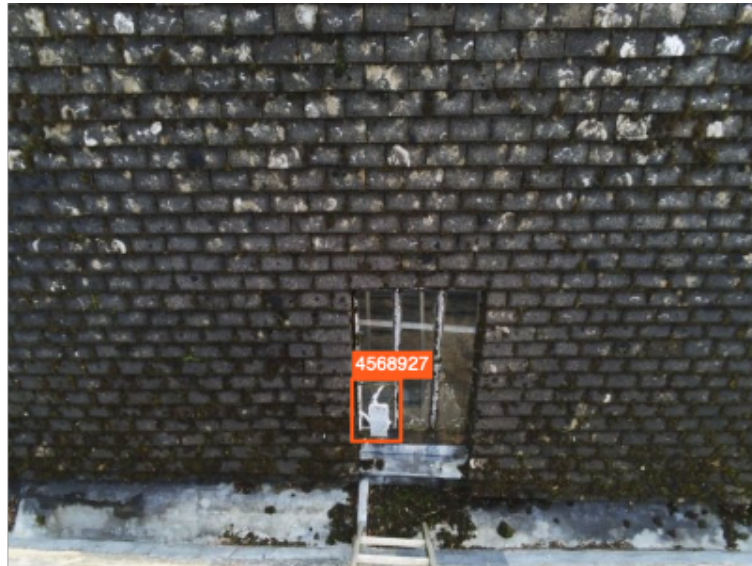
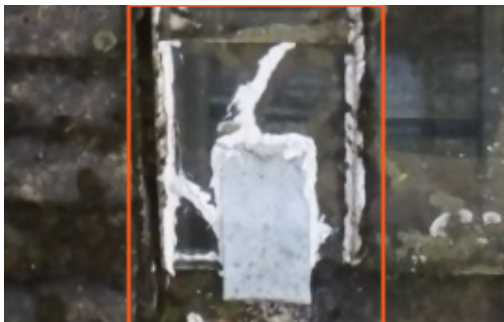
4568927 Severity: 3 Worn section

Broken glass pane to roof skylight

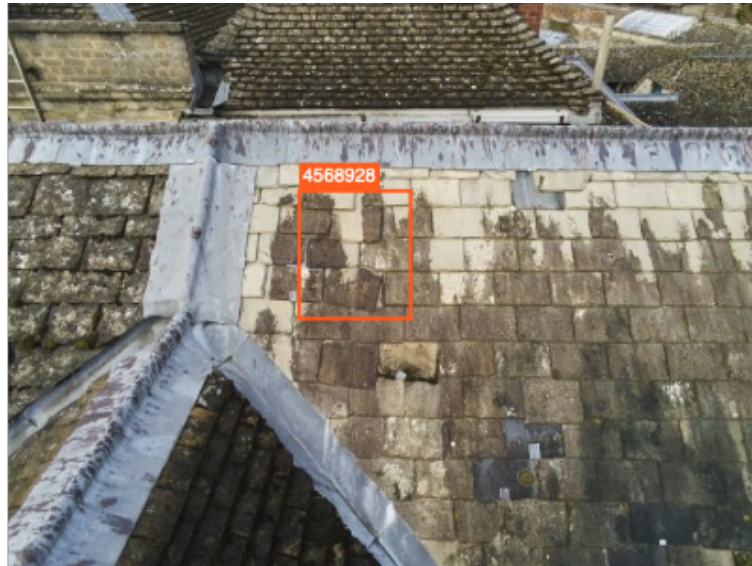
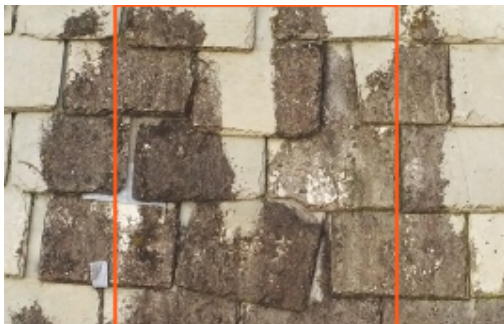
4568928 Severity: 3 Loose tile

Broken and slipped blue slates

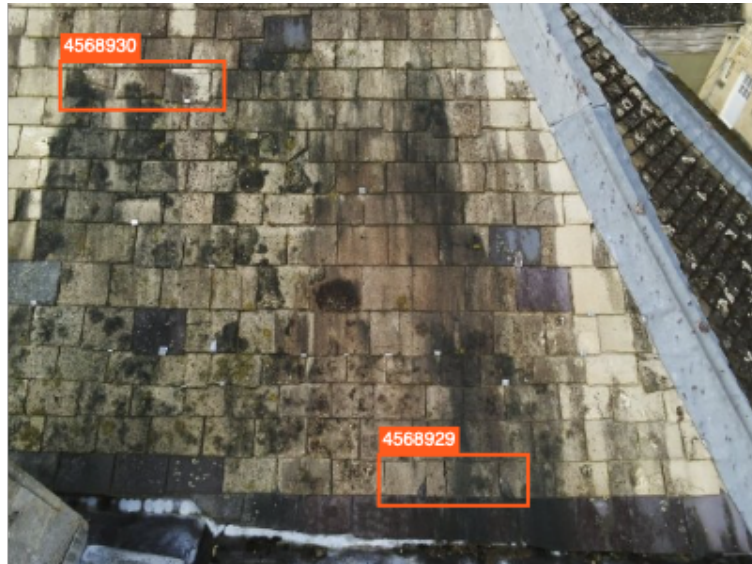
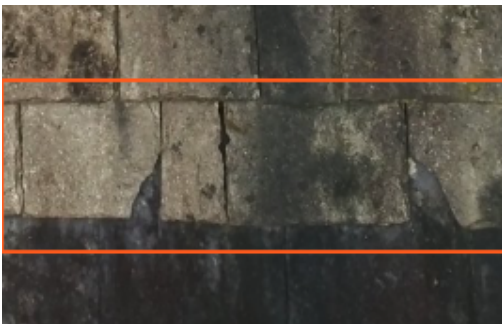
4568929 Severity: 3 Broken tile

**Alex Herman**  
Broken tiles

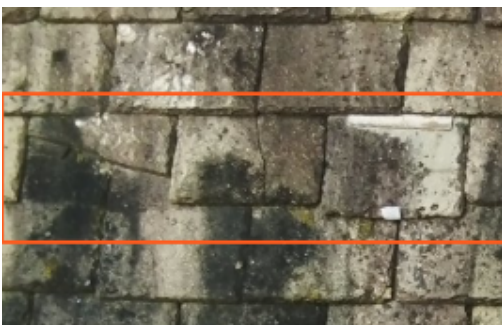
4568930 Severity: 3 Broken tile

**Alex Herman**  
Broken tiles

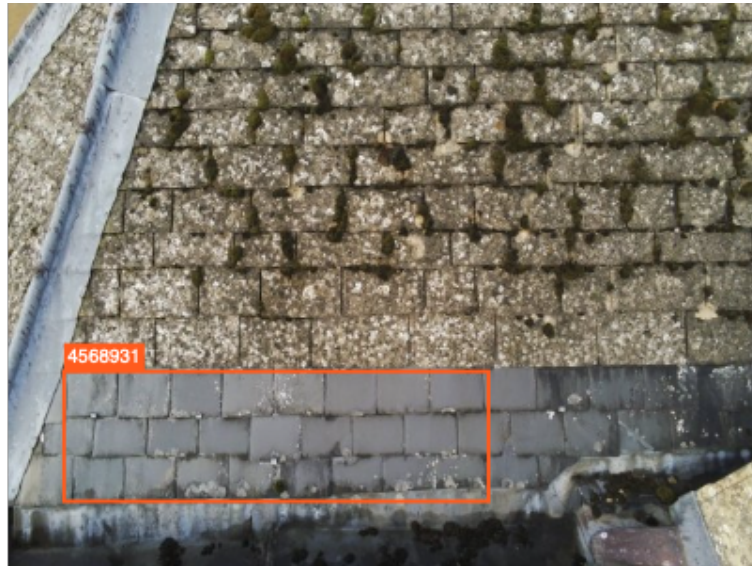
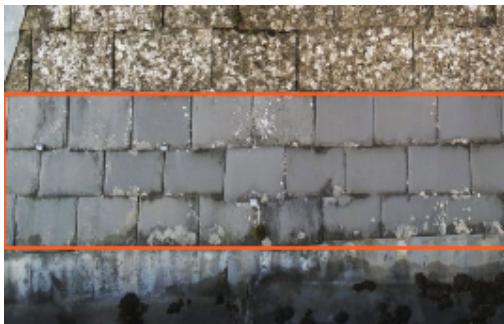
4568931 Severity: 3 Previous Repair

Blue slates installed to bottom 3 courses of artificial roof,  
minimal side lap in places

The roof looks to have been maintained to a reasonably high standard. In sections there are questionable repairs carried out. Predominantly being the blue slates installed to the bottom courses of the Eastern Slopes of Elevations K. The roof could benefit from a team of roofing specialists (particularly stone slaters) going over the roof and carrying out remedial repairs. I would expect this to be in the region of 10 working days work. There may be questions arisen regarding the most northern section of the east facing elevations of section K. The blue slates are starting to break down and whilst remedial repairs should be considered to start with a re-roof of this section may be required in the near future.

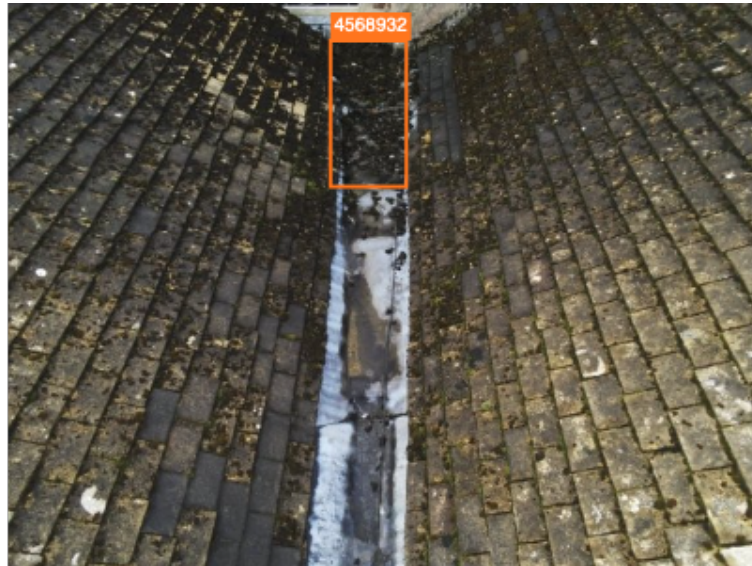
4568932 Severity: 2 Debris

Moss build up in box gutter

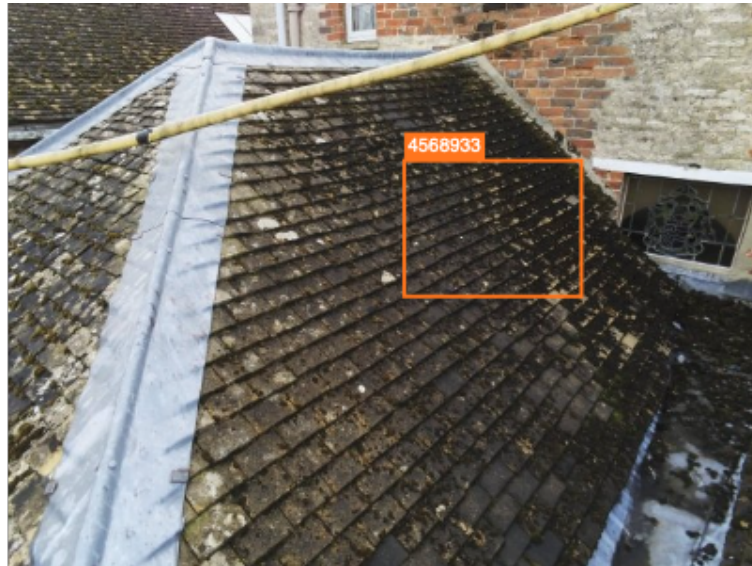
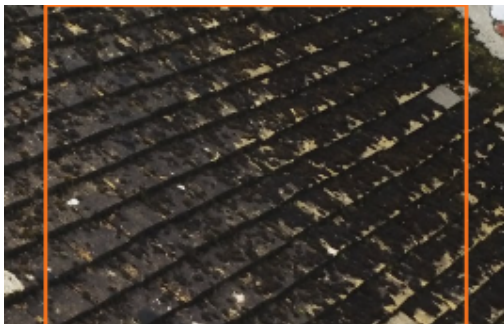
4568933 Severity: 2 Vegetation

Moss build up on roof to be cleared by a scraping method

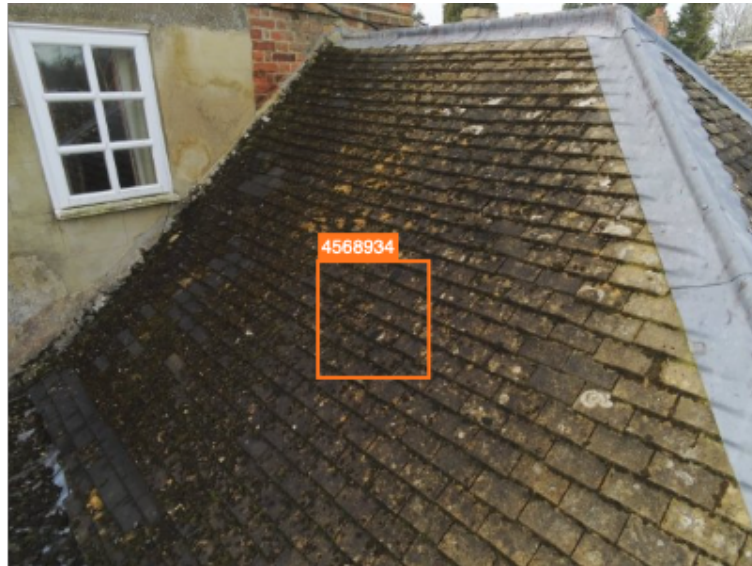
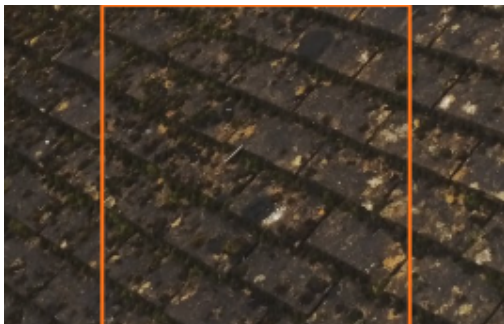
4568934 Severity: 2 Vegetation

Moss build up on roof to be cleared by a scraping method

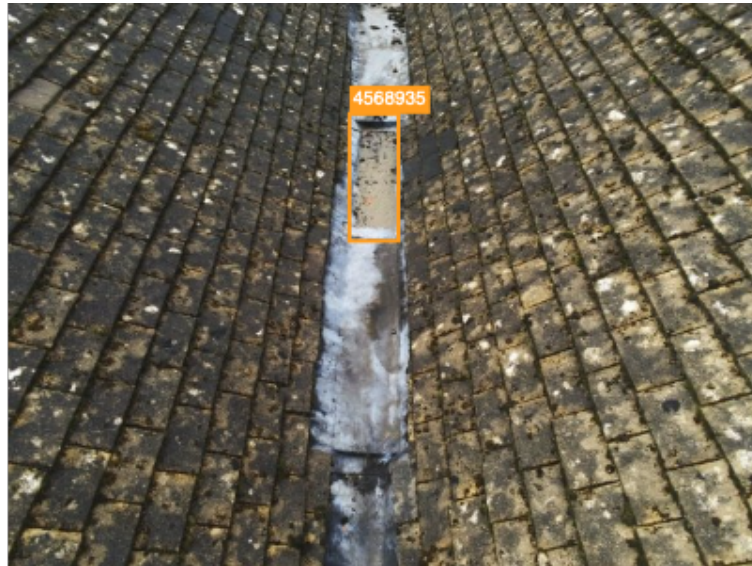
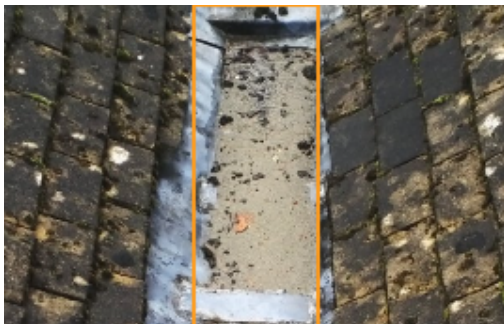
4568935 Severity: 1 Previous Repair

Past remedial repair to box gutter, area to be monitored for water ingress

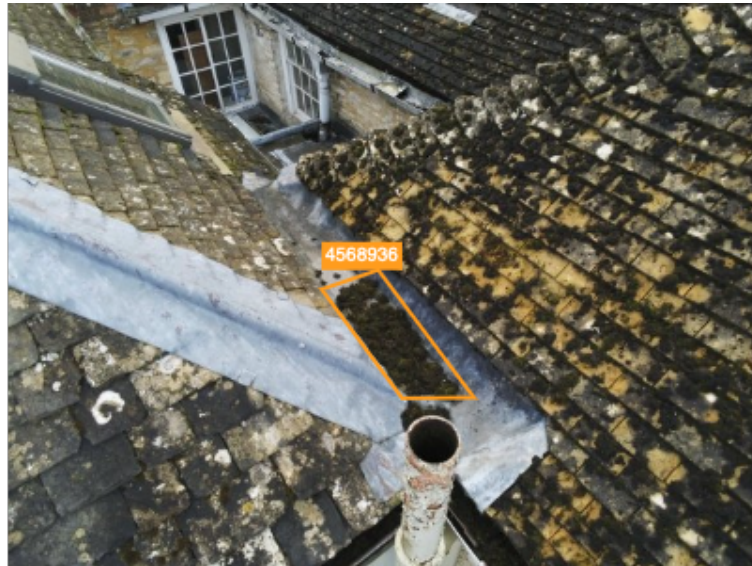
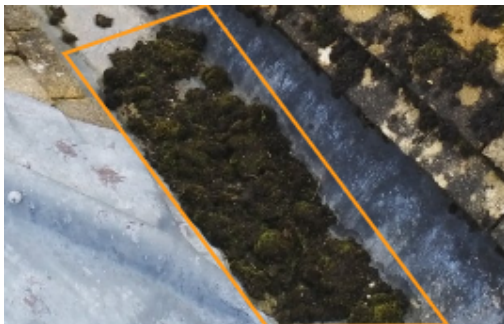
4568936 Severity: 1 Debris

Small amount of debris build up in box gutter

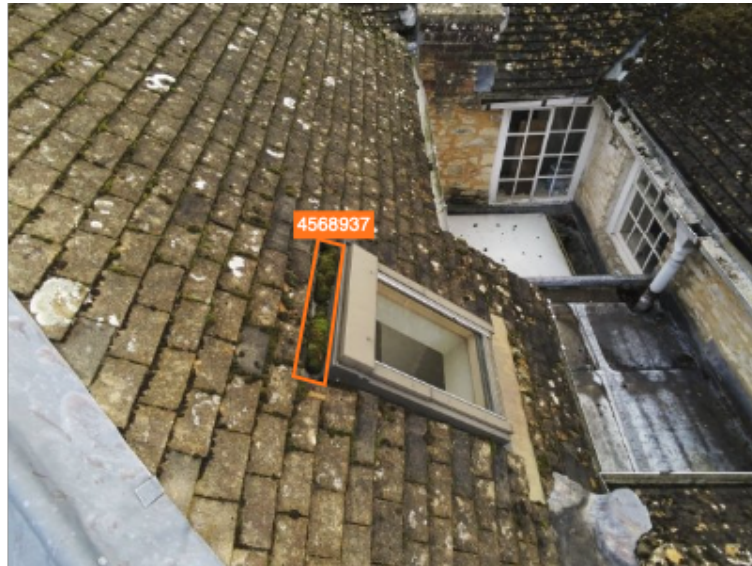
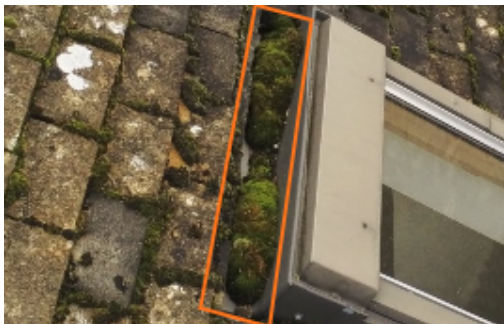
4568937 Severity: 2 Vegetation

Moss build up to back of Velux window

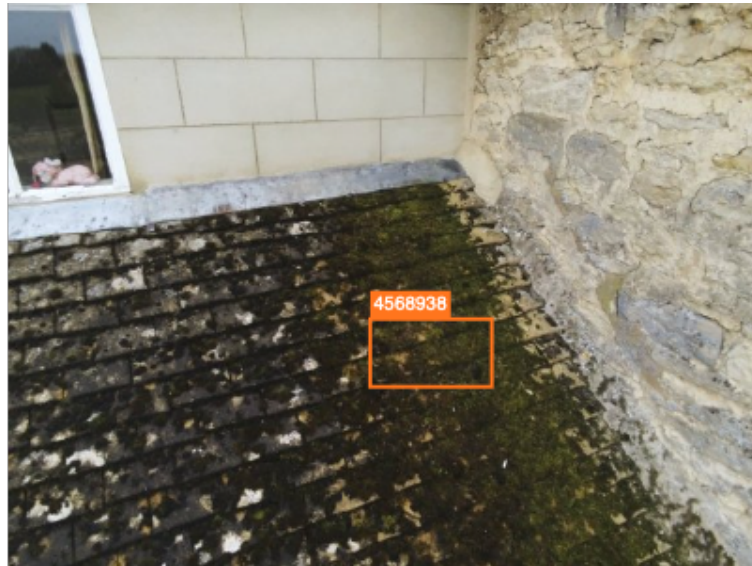
4568938 Severity: 2 Vegetation

Moss build up on roof elevation, to be cleared by a scraping method

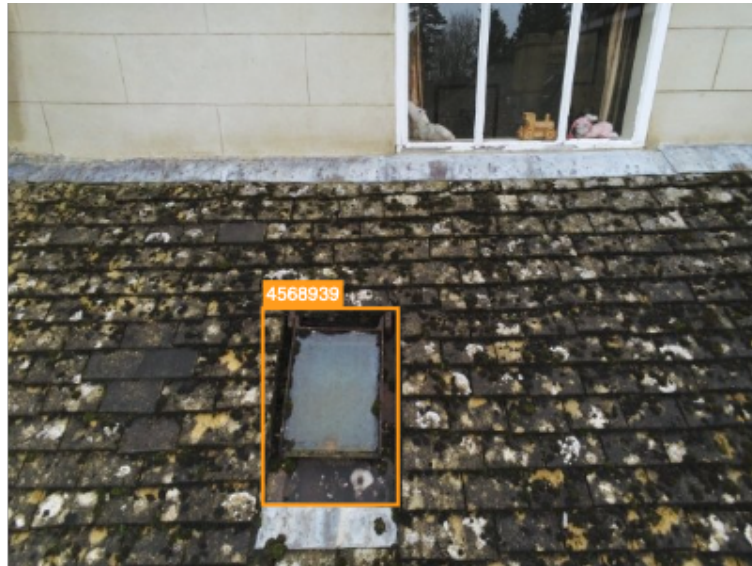
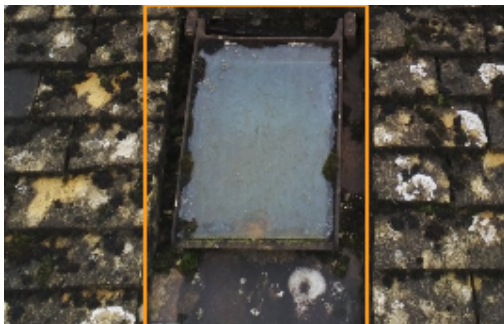
4568939 Severity: 1 Worn section

Old roof light, area to be monitored for water ingress

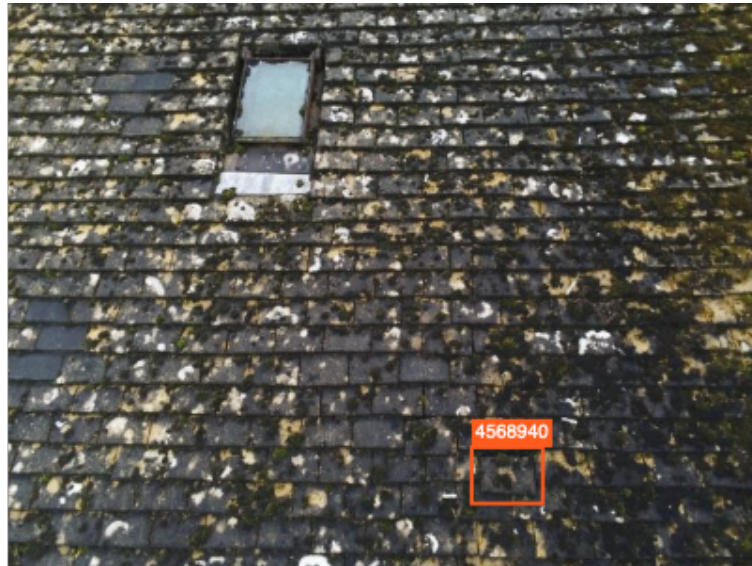
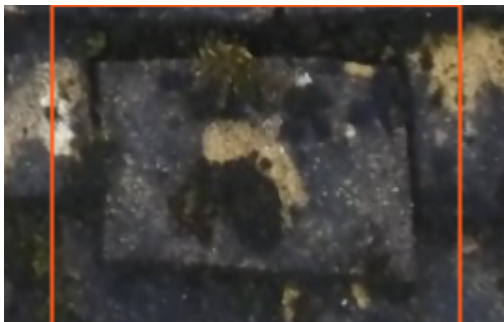
4568940 Severity: 3 Broken tile

Broken tile

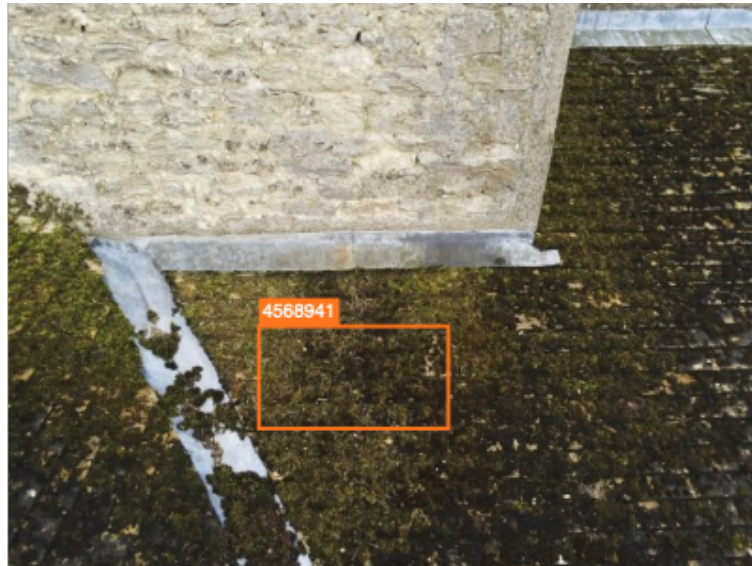
4568941 Severity: 2 Vegetation

Moss build up on roof elevation, to be cleared by a scraping method

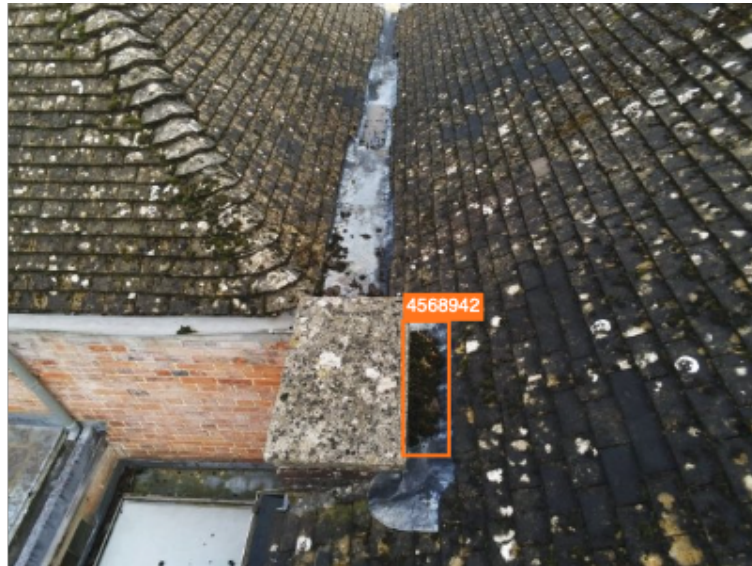
4568942 Severity: 2 Vegetation

Moss build up to back gutter to be cleared

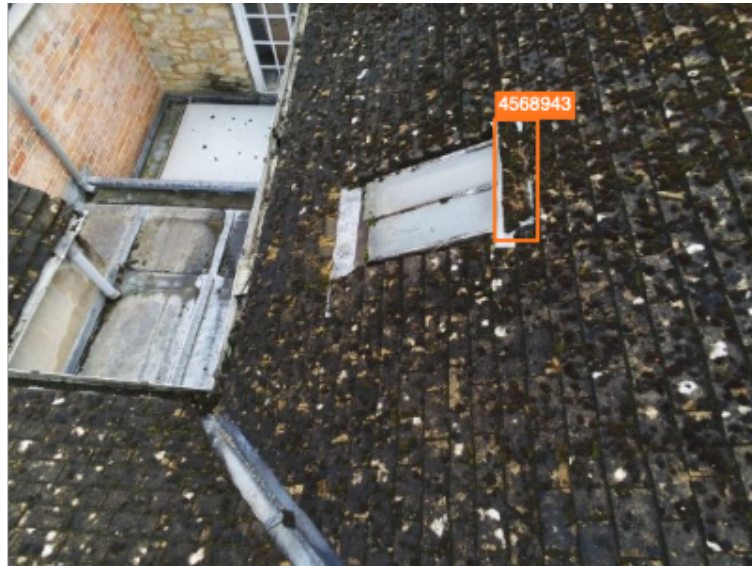
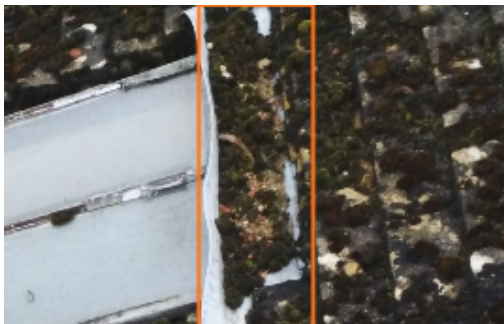
4568943 Severity: 2 Vegetation

Moss build up to top of roof light to be cleared

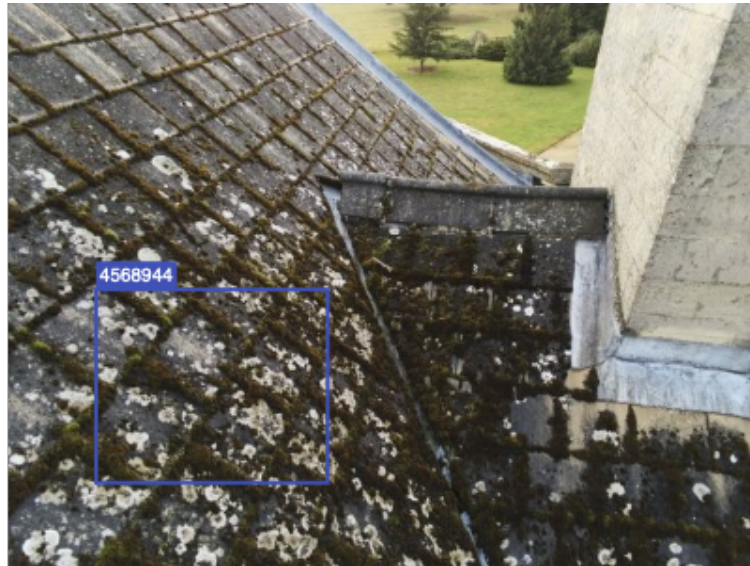
4568944 Severity: 0 POI

Example of Marley Eternit roof tile. May contain asbestos

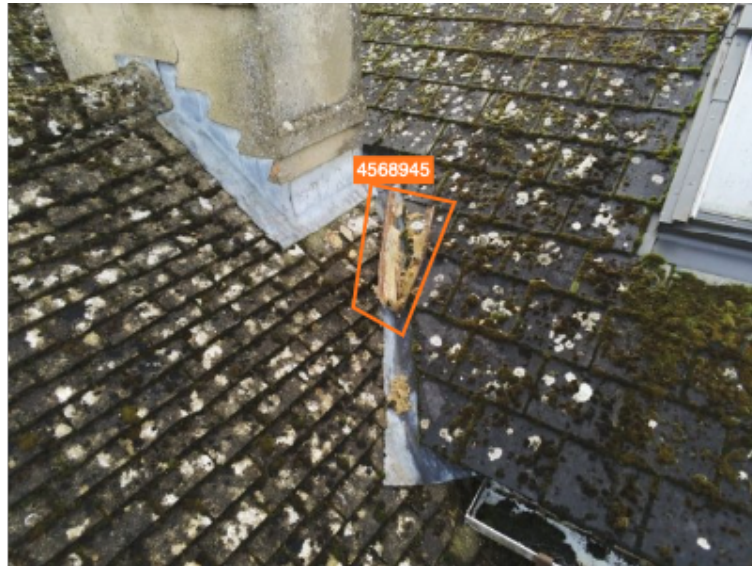
4568945 Severity: 2 Debris

Debris in valley gutter to be cleared

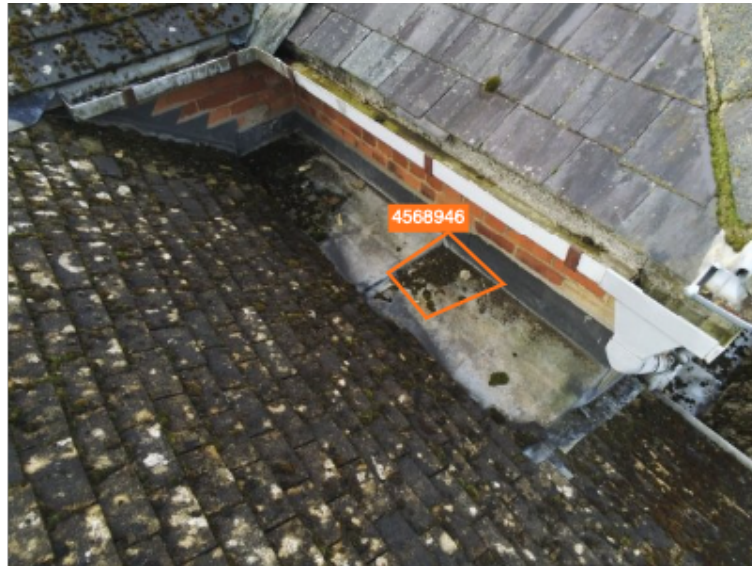
4568946 Severity: 2 Vegetation

Moss build up in box gutter to be cleared

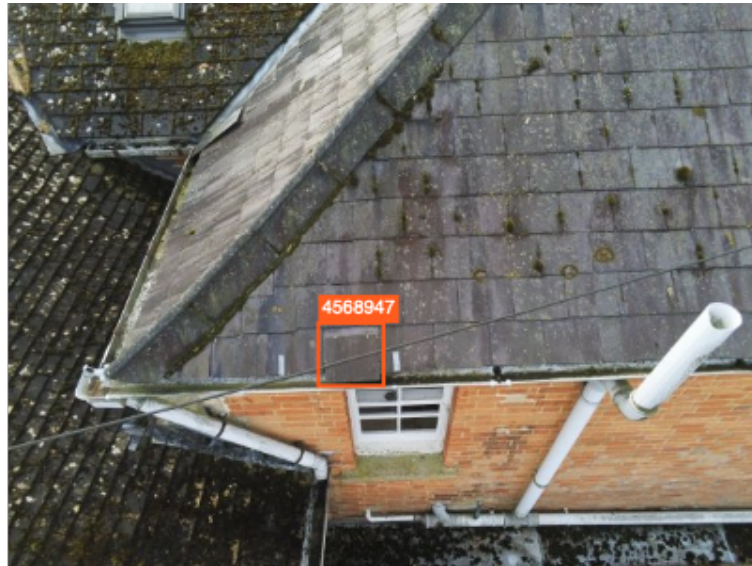
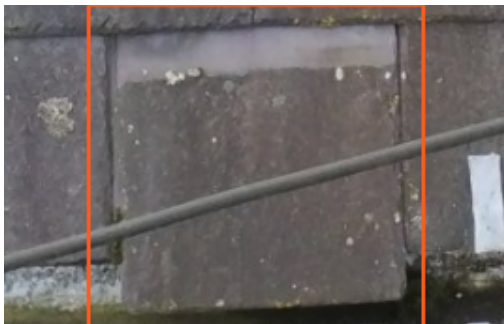
4568947 Severity: 3 Loose tile

Slipped slate at eave level

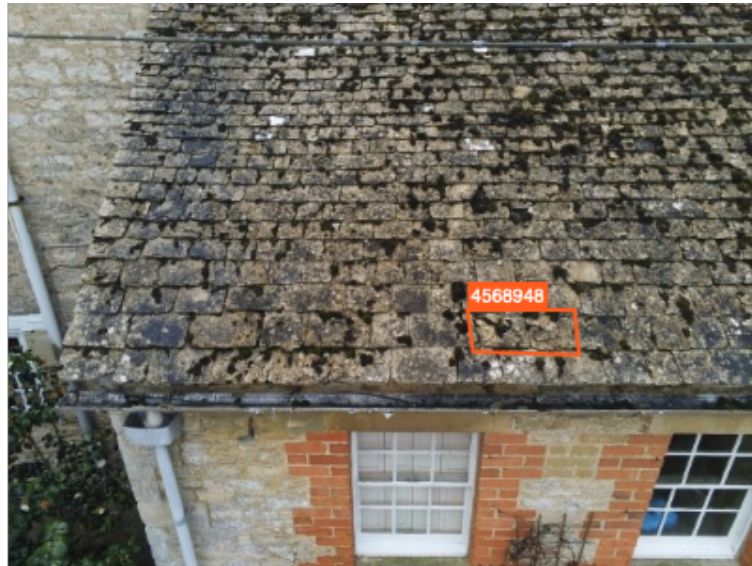
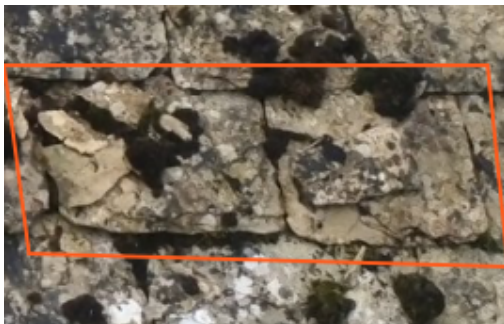
4568948 Severity: 3 Broken Slate

Slate delamination present on second course, area to be monitored

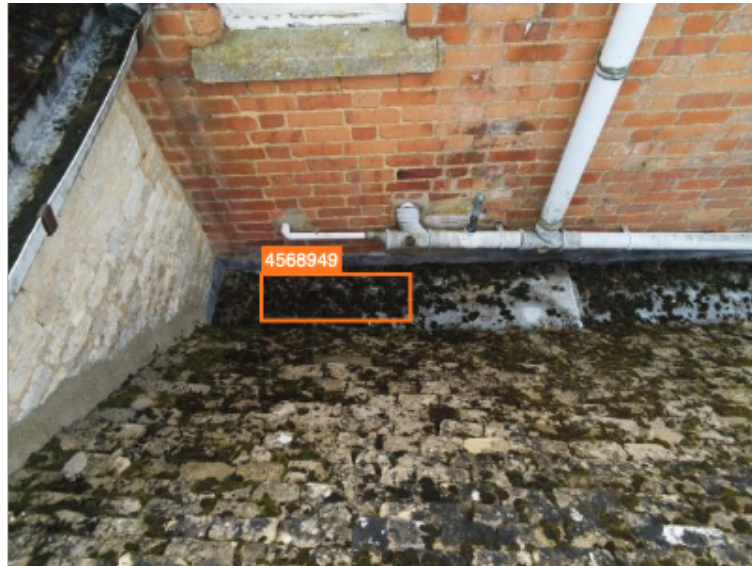
4568949 Severity: 2 Vegetation

Moss build up in box gutter to be cleared

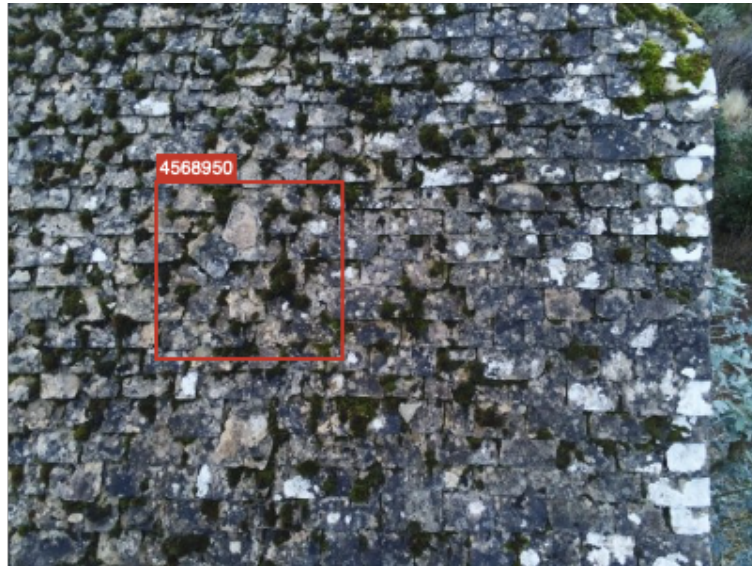
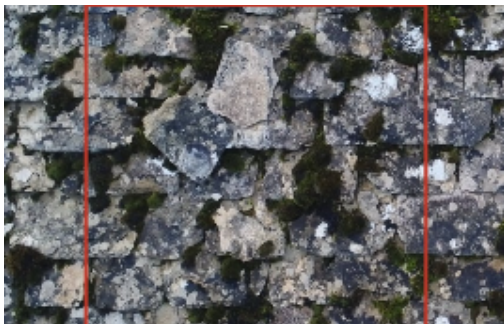
4568950 Severity: 5 Broken Slate

Slate delamination present on whole elevation and signs of slippage. Re-roof required

Elevations marked as A are completely at the end of their lifespan and this section of roof will require a re-roof soon. There are signs of slippage and high rates of delamination. Whilst this re-roof is carried out, I would advise getting the roofers to spend a couple of weeks going around the building carrying out remedial repairs, clearing debris from box gutters & parapets and possibly dressing flashings back into place where they may have slipped.

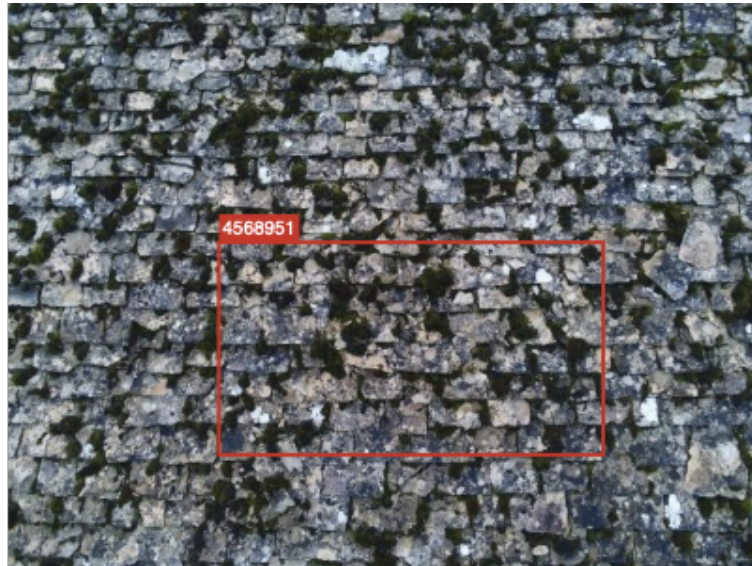
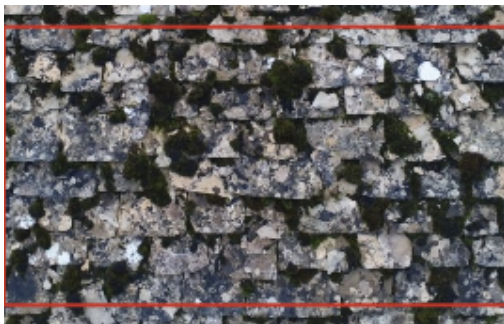
4568951 Severity: 5 Broken Slate

Slate delamination present on whole elevation and signs of slippage. Re-roof required

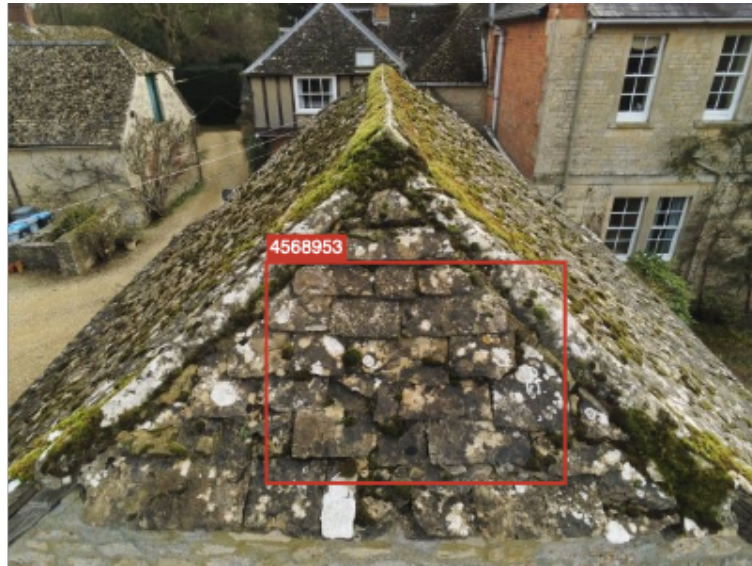
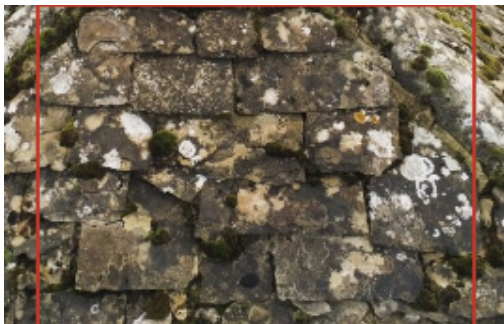
4568953 Severity: 5 Broken Slate

Slate delamination to barn style hip end

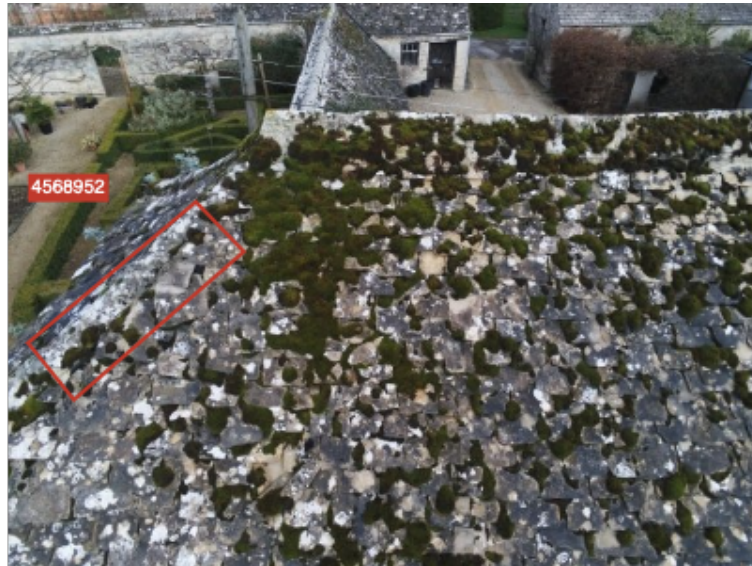
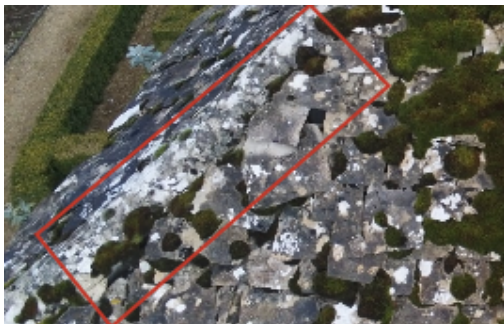
4568952 Severity: 5 Broken Slate

Mortar flaunching to hip end failing, high levels of slippage.

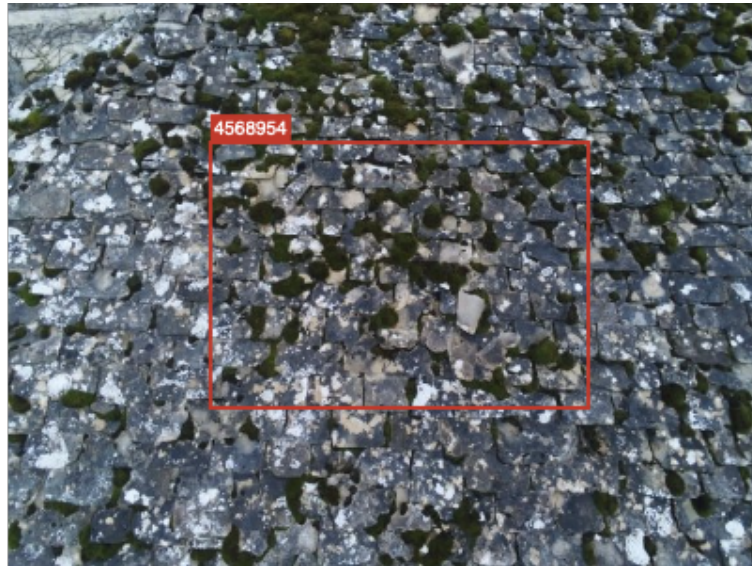
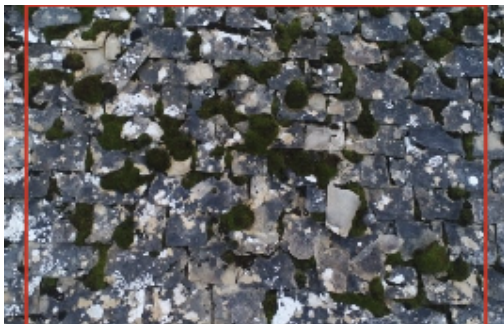
4568954 Severity: 5 Broken Slate

High levels of slippage and delamination present

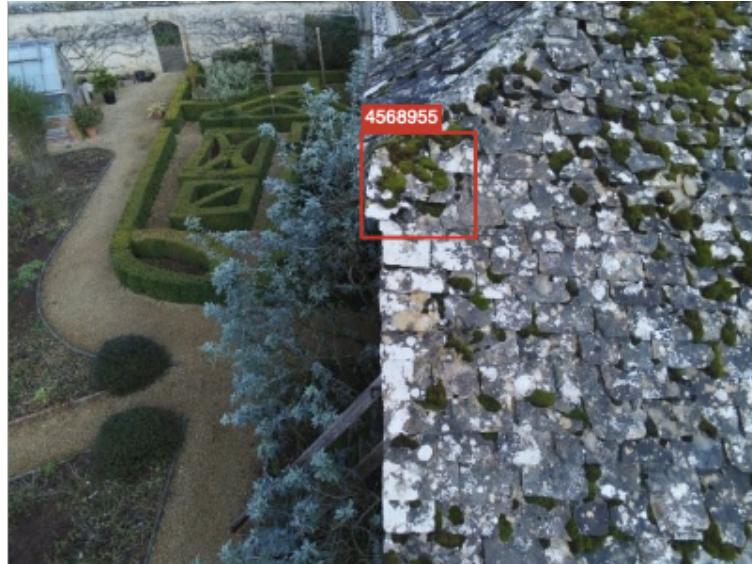
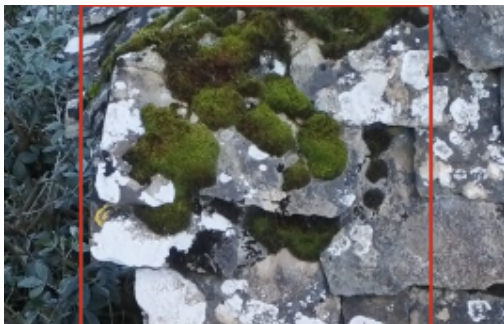
4568955 Severity: 5 Worn section

Movement in verge detail

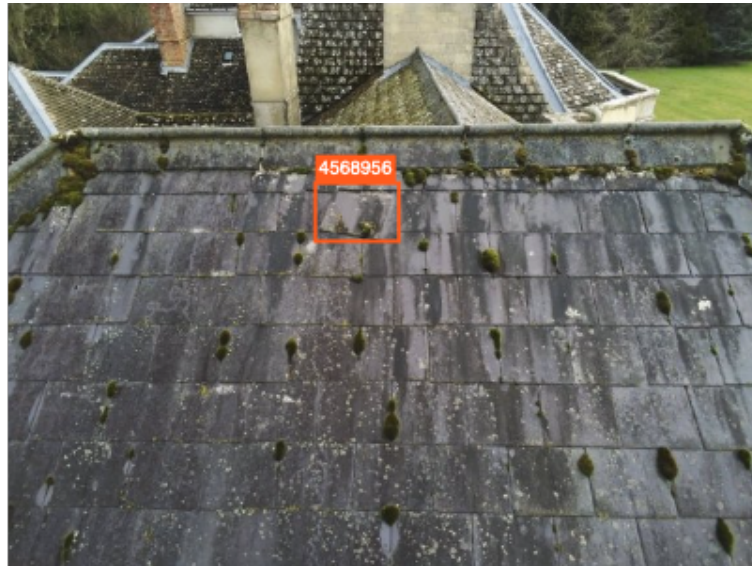
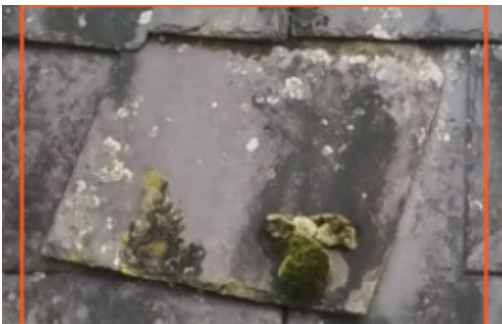
4568956 Severity: 3 Loose tile

Loose tile to top course

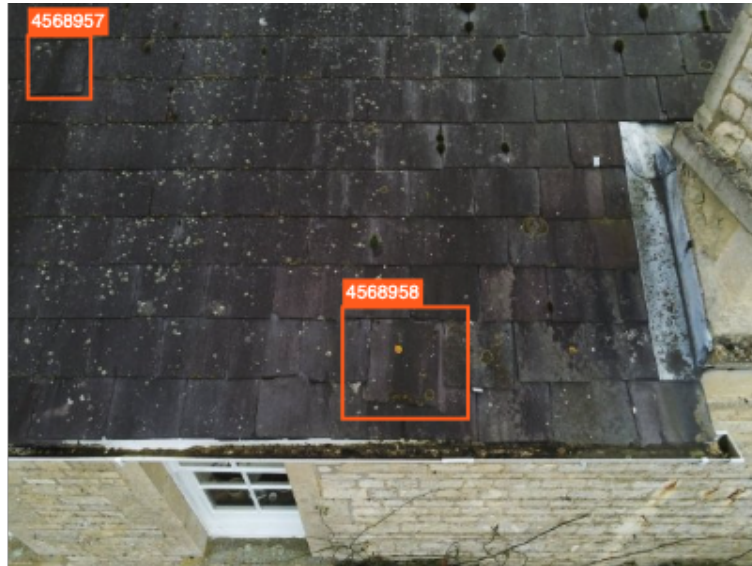
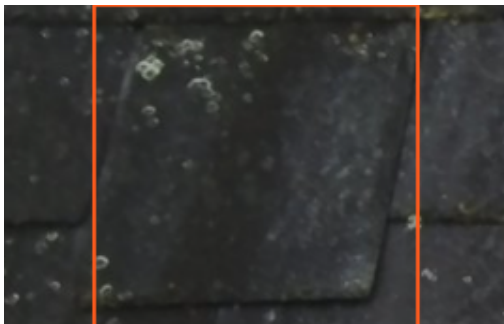
4568957 Severity: 3 Loose tile

Slipped tile

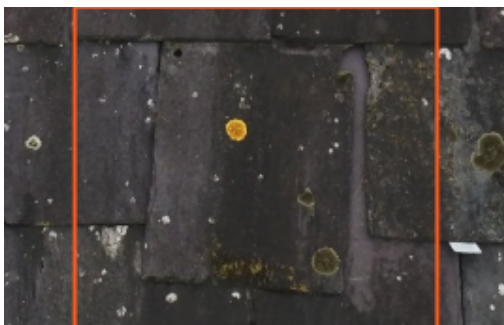
4568958 Severity: 3 Loose tile

Slipped tile
