# Full View

18th February 2022

RE: Report of the Roof Coverings at [REDACTED] via drone.

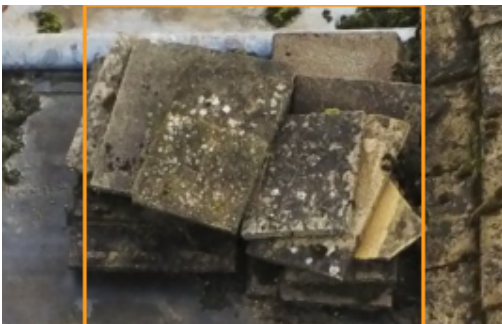
4568924 Severity: 1 Debris

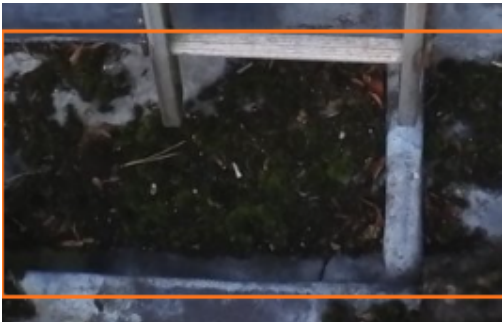
4568926 Severity: 2 Debris

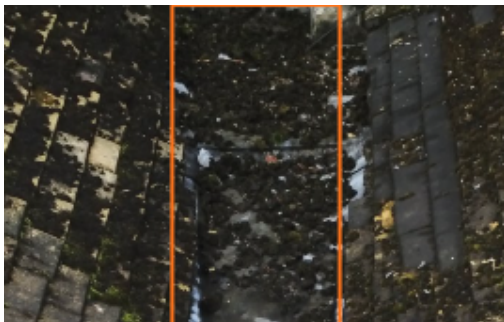
4568932 Severity: 2 Debris

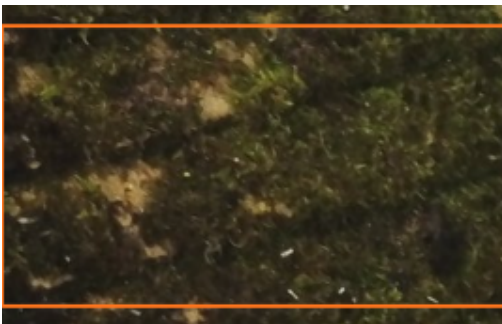
4568938 Severity: 2 Vegetation

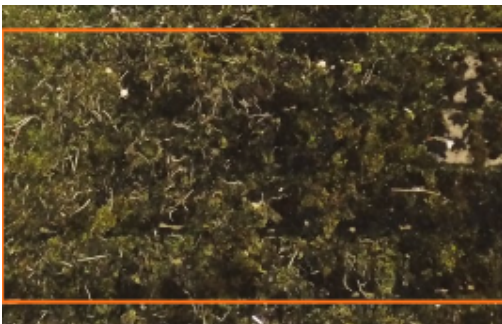
4568941 Severity: 2 Vegetation

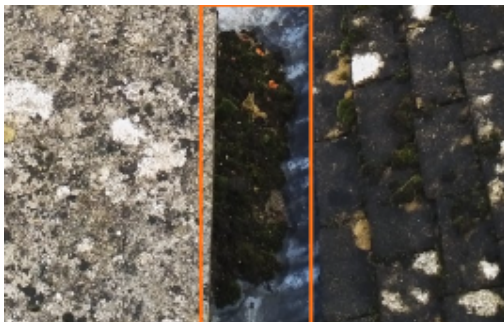
4568942 Severity: 2 Vegetation

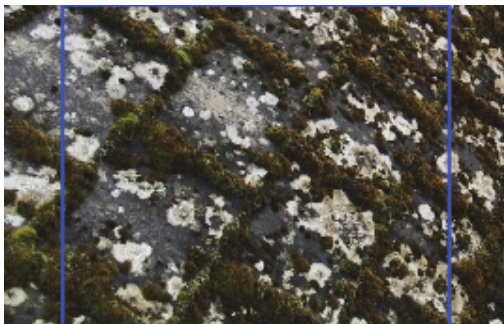
4568944 Severity: 0 POI

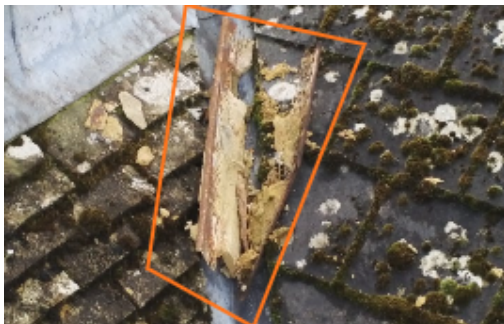
4568945 Severity: 2 Debris

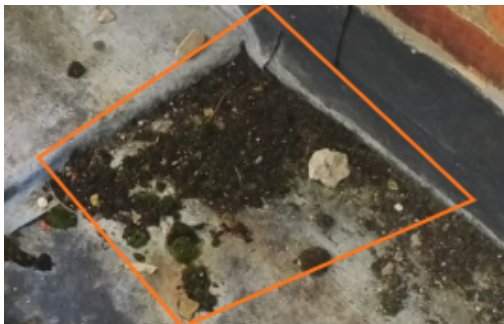
4568946 Severity: 2 Vegetation

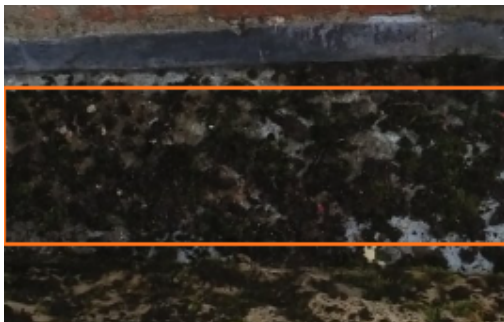
4568949 Severity: 2 Vegetation
